PREVENTING WATER INGRESS

In the first of a series on disc brake servicing, MEI Brakes has some practical tips on preventing water damage to brake calipers.

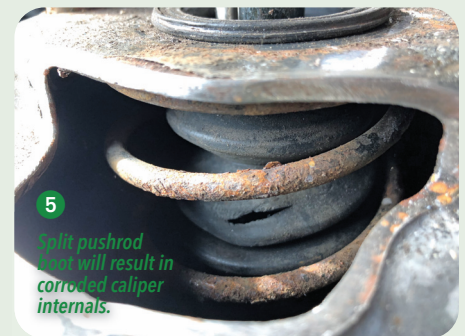
If water or rust staining is present on the pushrod, it is a clear sign that the pushrod seal/boot has split or is not seating correctly. (Fig 7)

2. After checking the flange seal, carefully inspect the visible part of the pushrod. If water or rust staining is present on the pushrod, it is a clear sign that the pushrod seal/boot has split or is not seating correctly. (Fig 7)

3. Next, examine the pushrod and the inner part of the seal for any damage or evidence of water entry through the boot. (See red boxes on Fig 1) It is difficult to see fully inside the boot, but a torch will help. Remember, if the pushrod shows signs of corrosion (after wiping away any grease), boot damage is the likely cause.

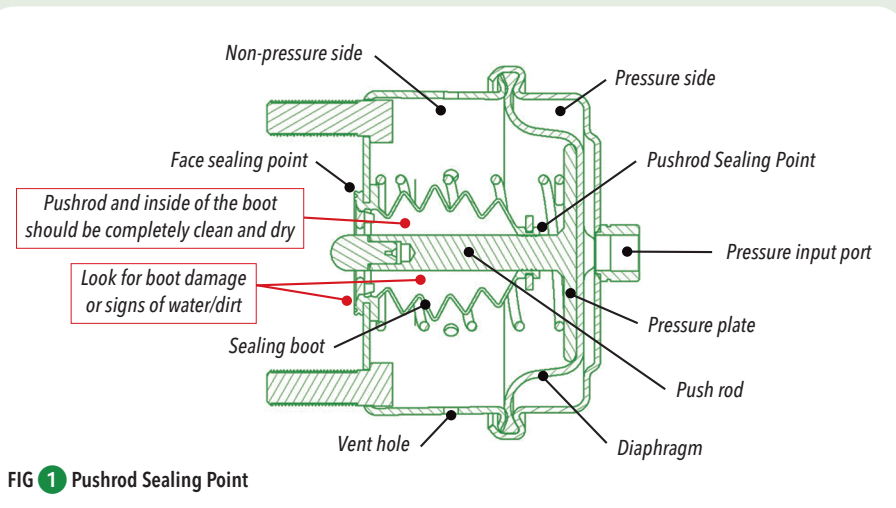
Note the face sealing point and pushrod sealing point in the layout of air chamber parts (Fig 1)
